## **EVALUATION OF A SELECTED SITE FOR A PROPOSED JOPLIN WATER SUPPLY RESERVOIR ON BAYNHAM BRANCH**

### **ADDENDUM 1 TO DECEMBER 29, 2020 REPORT**

**April 2, 2021**

**Thomas Aley, Missouri Registered Geologist 0989  
Senior Hydrogeologist and President  
and  
David Woods, Senior Project Scientist  
Ozark Underground Laboratory**

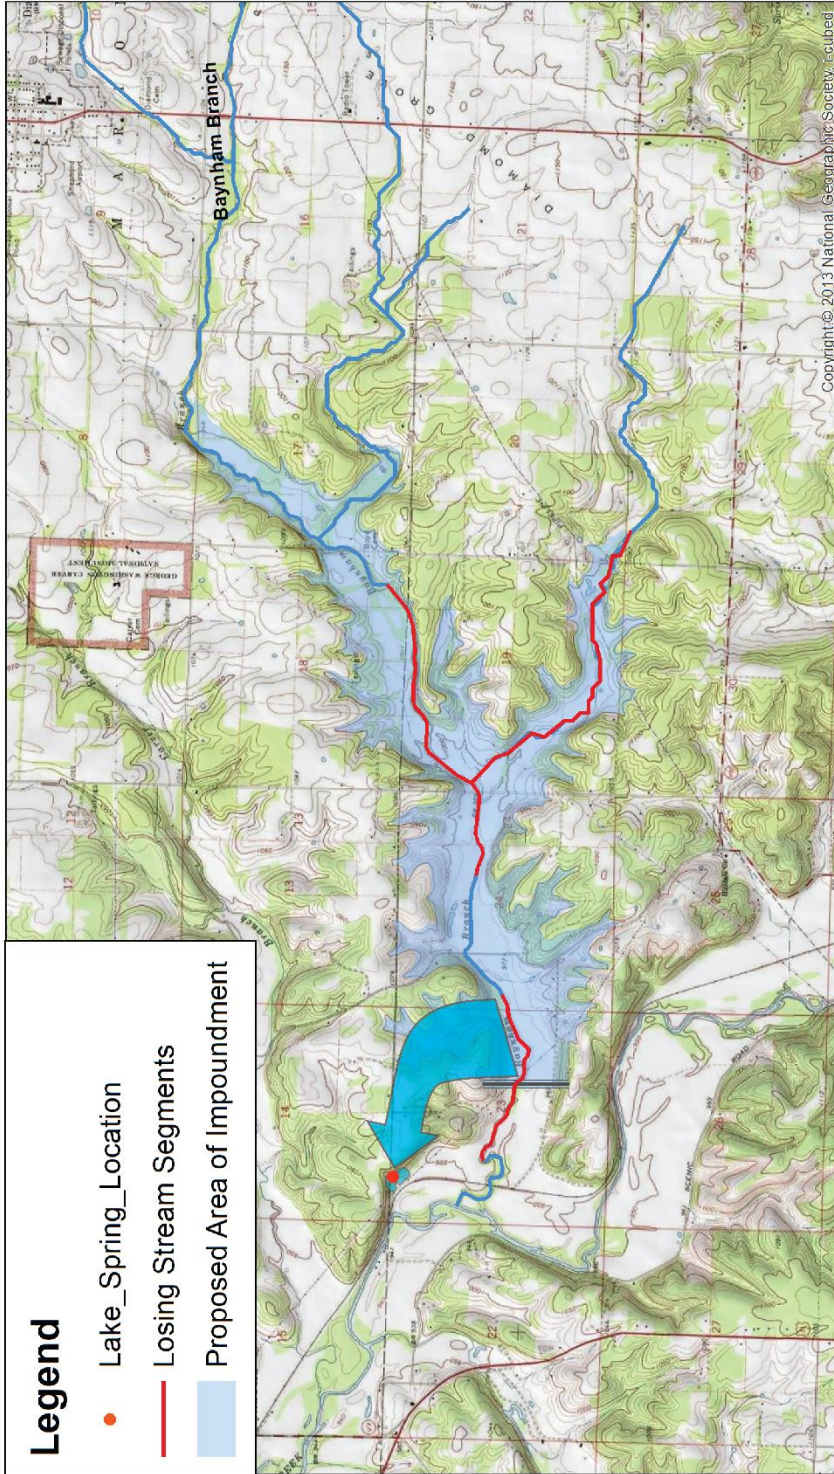
The large blue arrow in Figure 1 is based on dye tracing results and flow rate measurements. It diagrammatically shows that massive underground water leakage from the floor and sides of the planned reservoir will bypass the dam and discharge from the HFP Springs. As demonstrated by OUL streamflow measurements, leakage through groundwater occurs at multiple points.

Figure 1. The blue arrow diagrammatically shows that massive groundwater leakage from the floor and sides of the planned reservoir will bypass the planned dam and discharge from the HFP Springs. Validity of the diagram is proven by OUL groundwater tracing and flow rate measurements.

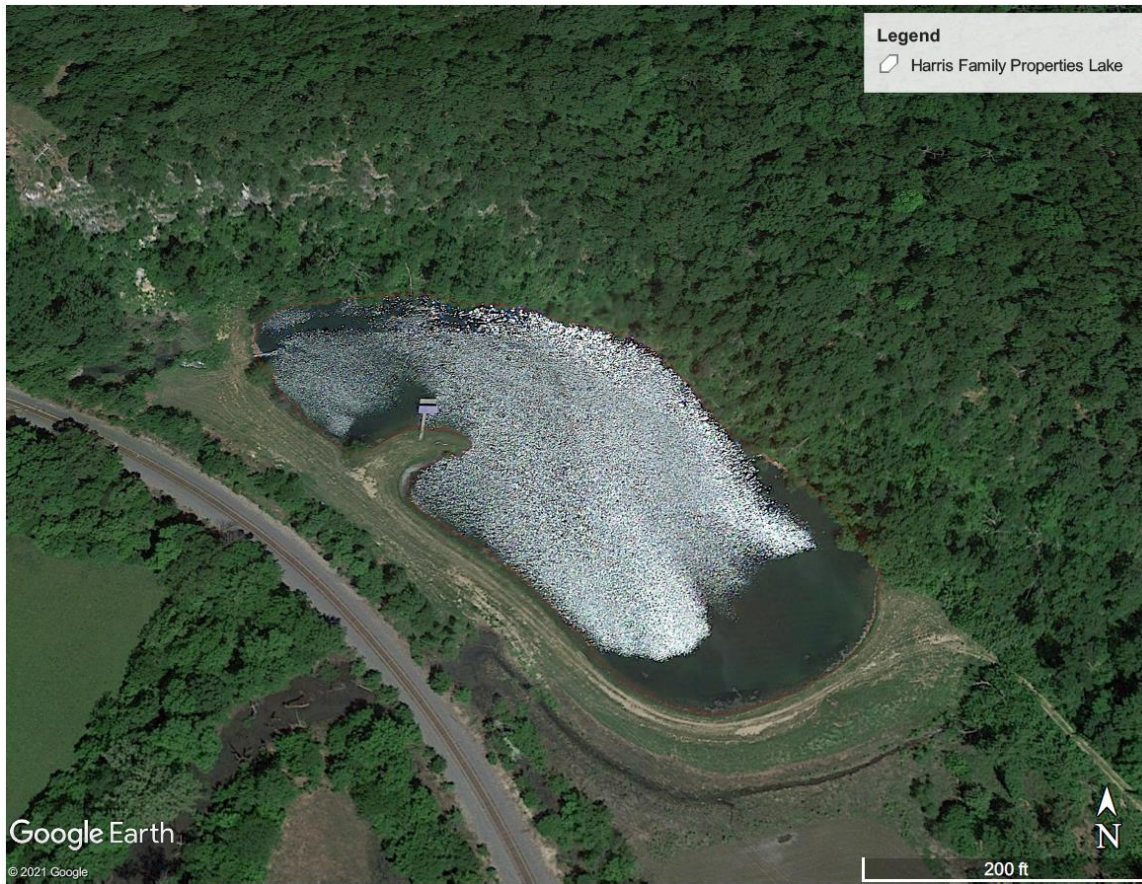
The largest of the HFP Springs (Lake Spring) discharges beneath the surface of a 3.2 acre lake on the Harris Family property and is the primary source of water for this lake. **Figure 2** is an aerial photograph of the lake. The spring that feeds the lake is located near the north shore of the lake at a point northeast of the peninsula that extends into the lake. Discharge from the lake is through a 3-foot diameter culvert at the western margin of the lake. A second spring rises at the base of the bluff and north of the drainage pipe from the lake. Additional springs are in the spring fed drainageway south of the lake. All of the springs have year-around flow. The combined flows from the HFP Springs discharges to Shoal Creek about 100 feet west of the western edge of Figure 2. The OUL has installed flow monitoring equipment at Lake Spring and in the spring-fed drainageway south of the lake.

**Figure 2. Lake and Harris Family Property Springs.**

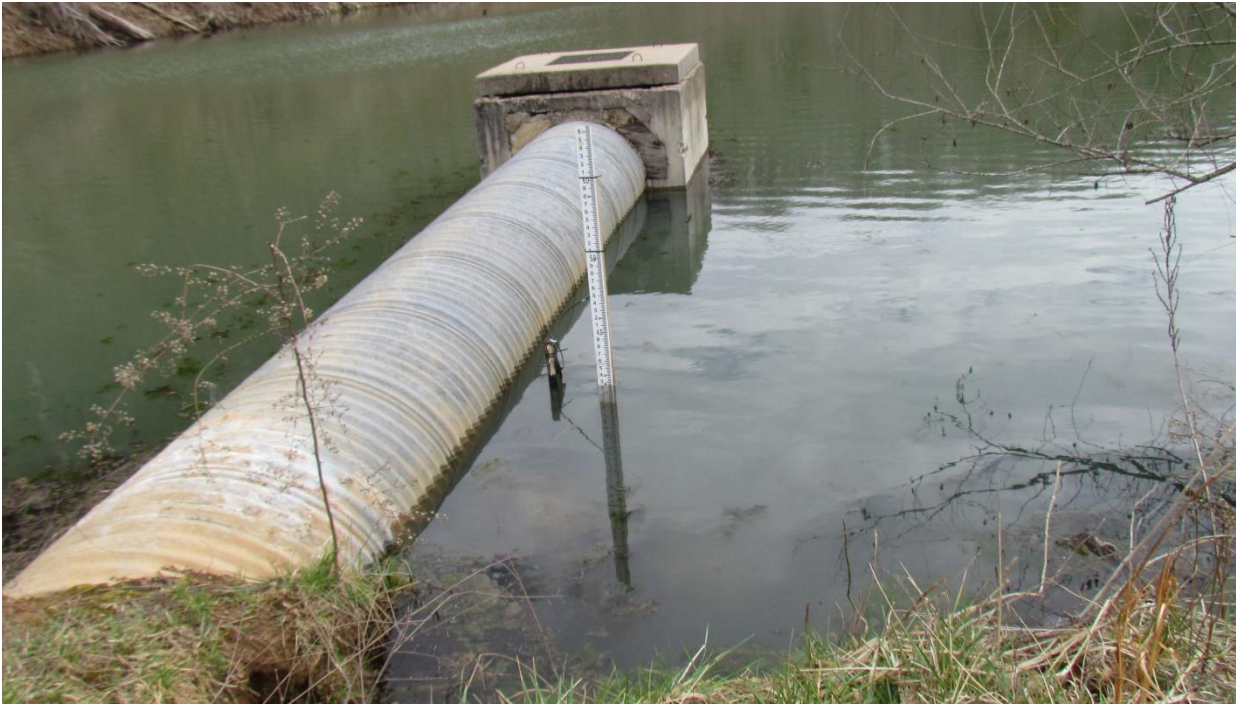
**Figure 3** shows the lake's discharge pipe, staff gage, and installed transducer that records water depths every 10 minutes. Based on calculated flow rates through the discharge pipe and stream flow measurements the OUL has develop a rating table (**Table 1**) that converts water depth data recorded by the transducer to flow rates in cubic feet per second (cfs) and million gallons per day (mgd). A rating table with water depths and flow rates at 0.01 foot intervals is used by the UL in calculating flow rates. These values are almost completely groundwater discharge from Lake Spring.

**Figure 3. Flow rate measuring equipment at Lake Spring.**

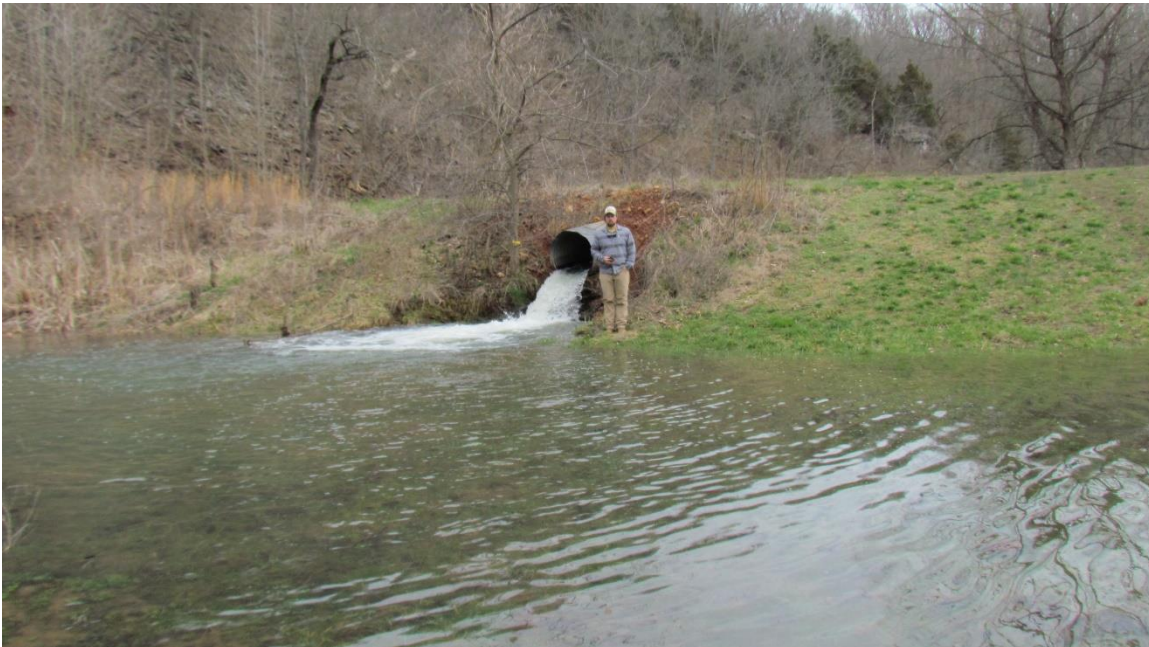
**Figure 4** is a photograph of water discharging from the outflow pipe at Lake Spring. Essentially all of the flow is from the spring. The photo was taken on March 15, 2021 at 12:10 PM and shows a flow rate of 11.57 million gallons per day. Peak spring flow during the period was 23.05 million gallons per day and occurred at 3:47 AM on March 15, 2021. The peak flow rate was almost exactly twice the rate shown in the photograph.

**Figure 4. Discharge of 11.57 mgd from the outflow pipe at Lake Spring. This flow is almost completely leakage from the planned reservoir area that would not be prevented by the dam.**

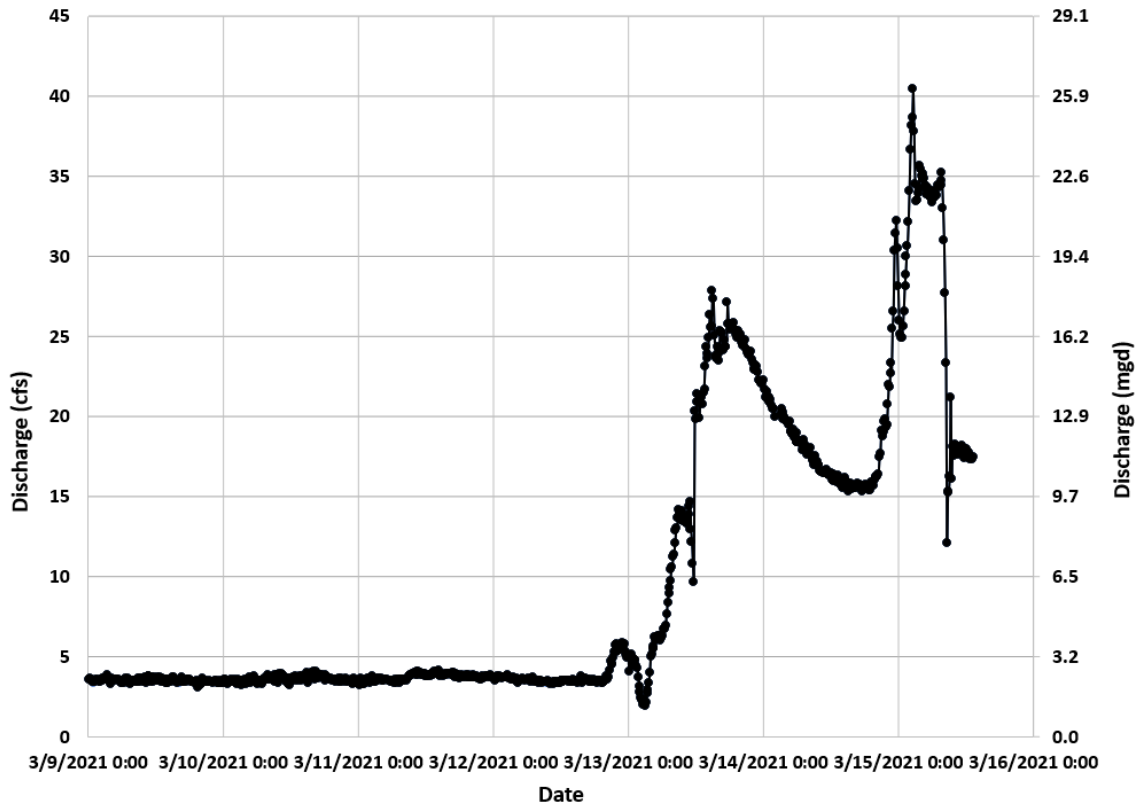
**Figure 5** is a graph of measured flow rates from Lake Spring during the period March 9 through 16, 2021. The short duration peaks that last about 40 minutes reflect intense precipitation falling on the lake.

Figure 5. Water flow rates from Lake Spring, March 9 to 16, 2021.

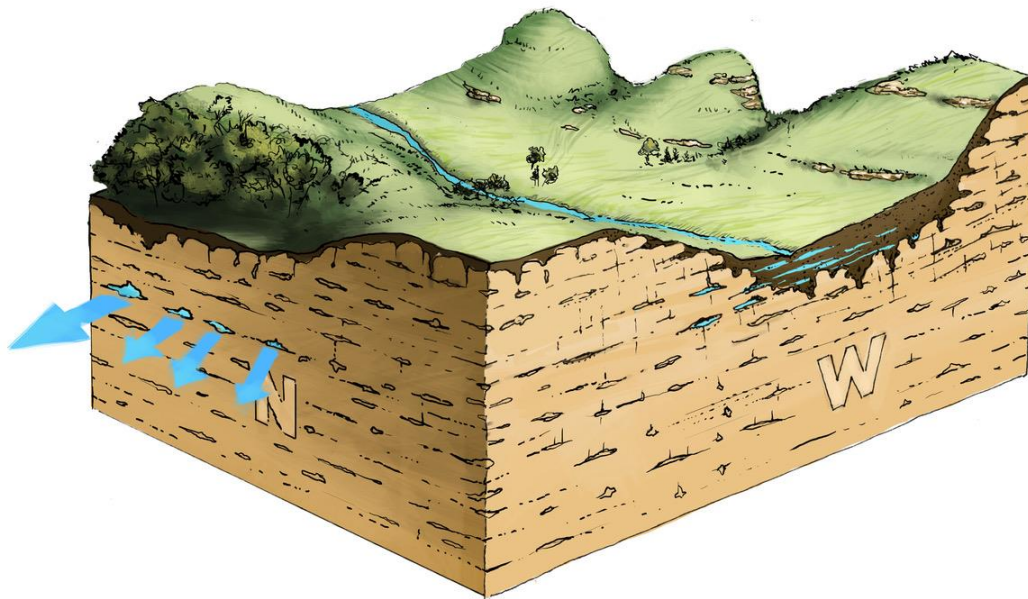
**Figure 6. Block diagram of Baynham Branch between Lime Kiln Road and planned dam site under existing natural conditions. The west side of the block is through the dam centerline.**

1. This diagram includes one of the three major losing stream segments on Baynham Branch within the planned reservoir area.
2. The limestone on the hillsides and beneath the valley is cavernous and very rapid groundwater flow at hundreds of feet per hour occurs through dissolved out bedrock openings. Cutters and pinnacles as described by Fellows (1965) are expected beneath the valley but may not be detected without very extensive drilling.

3. There is year-round flow at Lime Kiln Road. The stream sinks at numerous points downstream of that road as shown by measurements of stream flow rates. From mid-summer through early fall the entire flow of the stream usually enters groundwater before reaching the dam site.

4. Three separate dye tracing studies have shown that the water sinking in this area flows underground through the hill on the north side of the diagram and discharges from HFP Springs. Lake Spring is the largest of these. The blue arrows depict a few of the multiple flow routes. The planned dam would not block these groundwater flow routes.

5. The stream in the diagram is flowing at close to bank-full conditions such as existed on March 15, 2021 when peak flow from Lake Spring was 23.05 million gallons per day.

6. With very limited exceptions the soils in this valley have been mapped by the US Department of Agriculture (Aldrich, 1989) and found to have "Severe Limitations for Reservoir Areas Due to Severe Seepage". This is consistent with the loss of large volumes of surface water into groundwater under bank-full flow conditions.

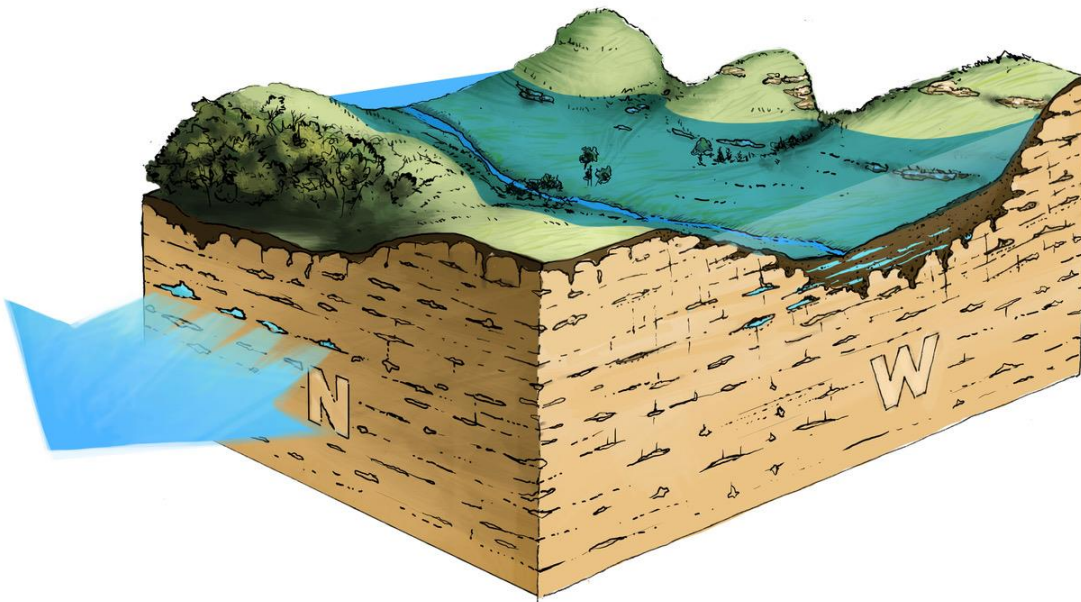
**Figure 7. Block diagram of Baynham Branch between Lime Kiln Road and planned dam site under reservoir conditions.**

1. If the reservoir operated as planned the depth of water at the dam would be approximately 100 feet. The elevation of the “normal pool” would be at an elevation of 1051 feet.

2. The leakage rate would dramatically increase over existing natural conditions as indicated by the large blue arrow. Water leaking from the reservoir through this losing stream segment will discharge from the HFP Springs and possibly additional locations.

3. Based on standard groundwater equations, pumping of water from Shoal Creek into the reservoir at rates in excess of 150 million gallons per day and for prolonged periods would be required to reach a “normal pool” level of 1051 feet. Pumping of water from Shoal Creek would be permitted only under high to moderately high flow conditions. Due to massive leakage from the reservoir it could not continuously supply 30 million gallons of water per day to Joplin water users under dry weather conditions.

4. There will be a net loss of water from the Shoal Creek basin due to evaporation from the planned 1,200 acre reservoir.
5. Low dissolved oxygen in bottom waters of the reservoir would kill Ozark cavefish populations within the impoundment area. This is a federally-listed Threatened Species.

6. With very limited exceptions the soils in this valley have been mapped by the US Department of Agriculture (Aldrich, 1989) and found to have “Severe Limitations for Embankments, Dikes, and Levees”. Building a high earth fill dam in a losing stream segment underlain by cavernous limestone units where excessive leakage is documented represents an unwise and risky undertaking (Aley et al., 1972).
